Date: February 26, 2001
Subject: Hackberry Pits
From: OSC Robert M. Ryan, P.E., U. S. EPA Region 6
To: Director, ERD
Charles A. Gazda, Chief, RPB, Region 6

Facility 12-E-1001, identified as the Hackberry Pit No. 1, is located in the East Hackberry Oil Field, within the Pete Seay Circle Road (Rd) residential area of Hackberry, Cameron Parish, Louisiana. The pit is located approximately 400 feet (ft.) south of Black Lake Bayou and 0.5 miles west of the Calcasieu Ship Channel. The facility is mapped in the Moss Lake USGS 7.5-minute quadrangle, within Section 37, Township 12 South, Range 10 East. The geographic center of Pit 1 is at Latitude 30° 00' 12" North and Longitude 93° 20' 27" West. The facility is accessible by land only. To reach the site, travel 700 ft. south on Highway 27 from Black Lake Bayou and turn left onto Pete Seay Circle Rd. Travel approximately 1,000-ft. on the north side of Pete Seay Circle Rd. and the pit will be located approximately 40-ft. to the south.

Photographic Documentation for Hackberry Pits

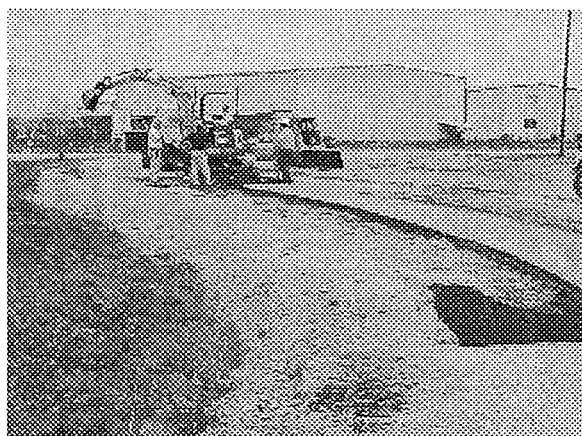
HACKP17-pic1.JPG: Asphalt crew fills cuts with fresh asphalt.

During the week of February 19, 2001, two sections of Pete Seay Circle were repaired by DaRousseau Construction Incorporated. The sections were cut on February 19 and filled on February 21, 2001. No additional work was required.

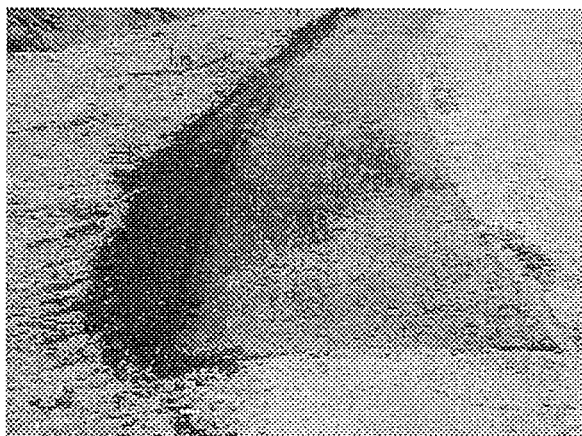
HACKP17-pic2.JPG: Completed repair of asphalt on south side of curve near 109 Pete Seay Circle.

HACKP17-pic2.JPG: Completed repair of asphalt on southside of curve near 109 Pete Seay Circle.
